Composite Overwrapped Pressure Vessels

EXECUTIVE SUMMARY FOR DATABASE EXTENSION TASK 3.0 AND IMPACT DAMAGE EFFECTS CONTROL TASK 8.0

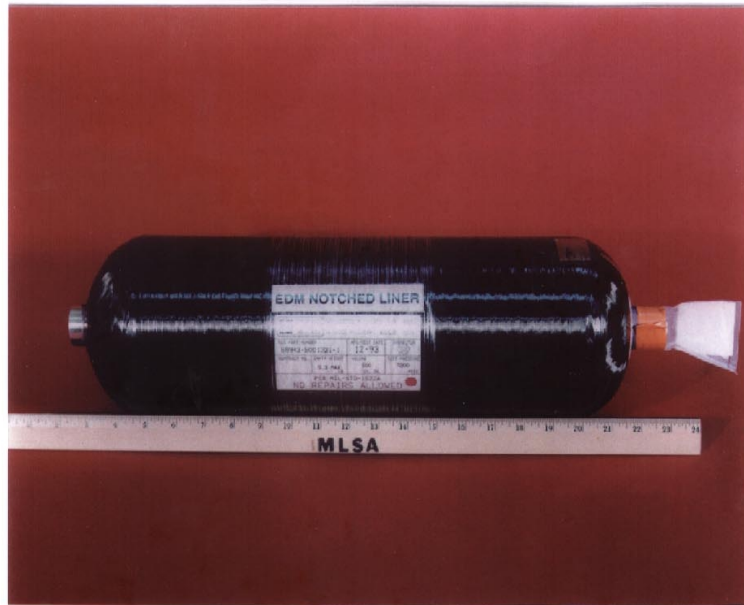
Figure 1B-1. Graphite composite overwrapped pressure vessel (GCOPV). Vessel was designed for inert pneumatic gas storage up to 7000 psi.

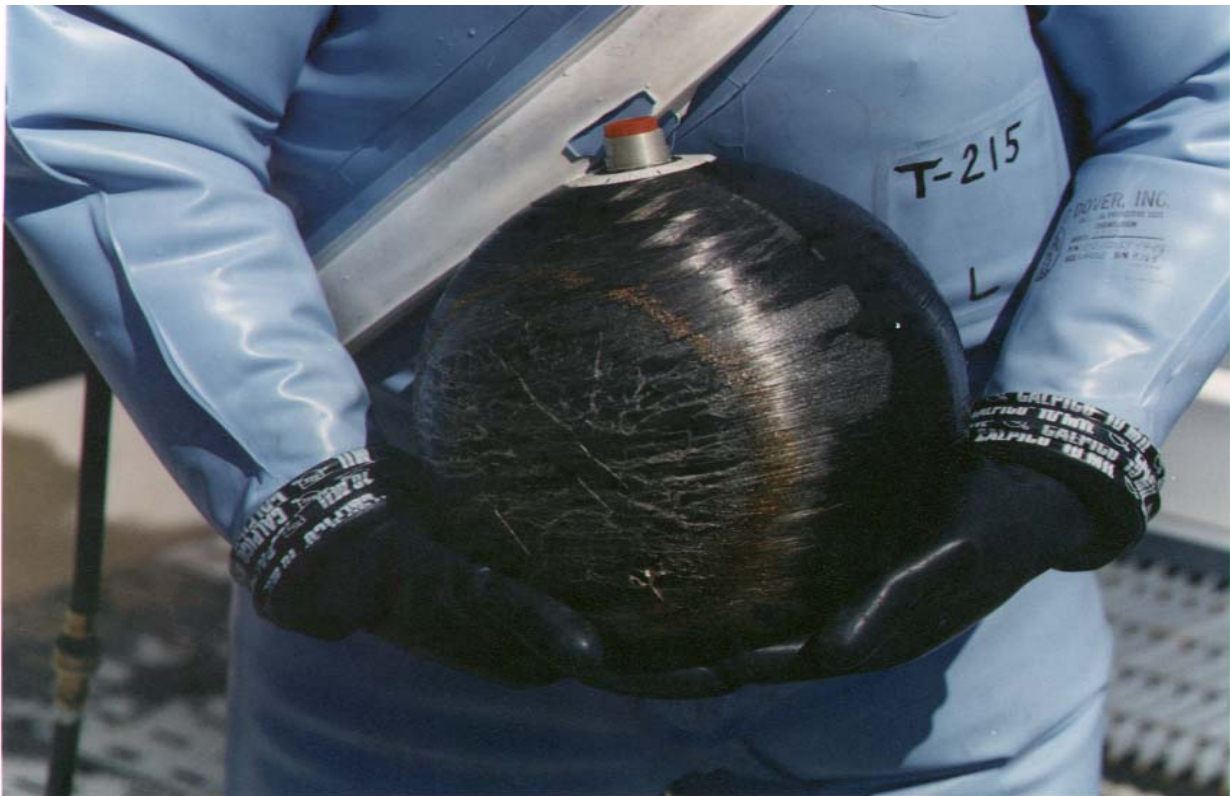
Figure 3-1. Typical post-exposure COPV.

We measured no significant effect on burst strength after exposing Lincoln Composites Model 220088-1 Gr/Ep COPVs to the space vehicle fluids N_2H_4 , N_2O_4 , or LOX under simulated launch pad leak scenarios.

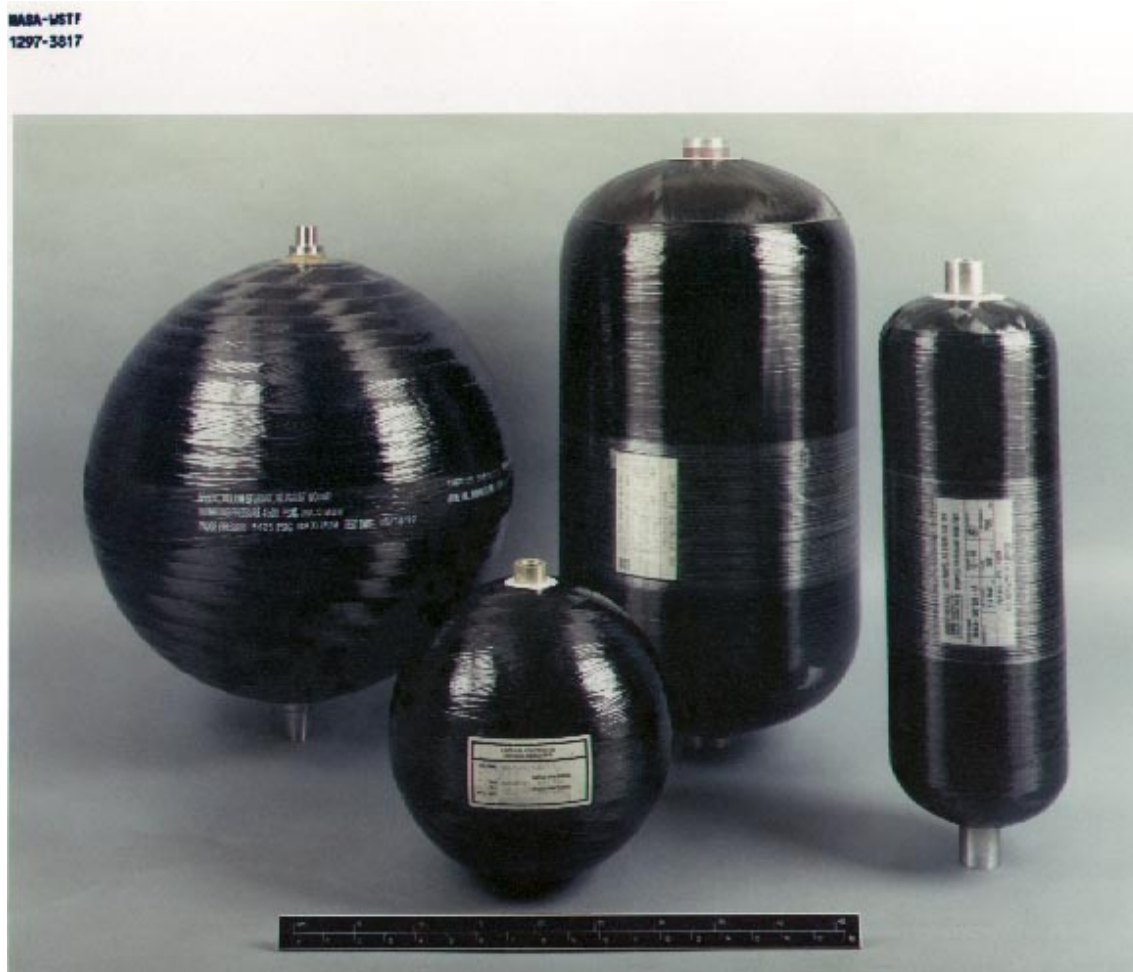
Figure 6-1. COPV types used for Subtask 3.4 testing.

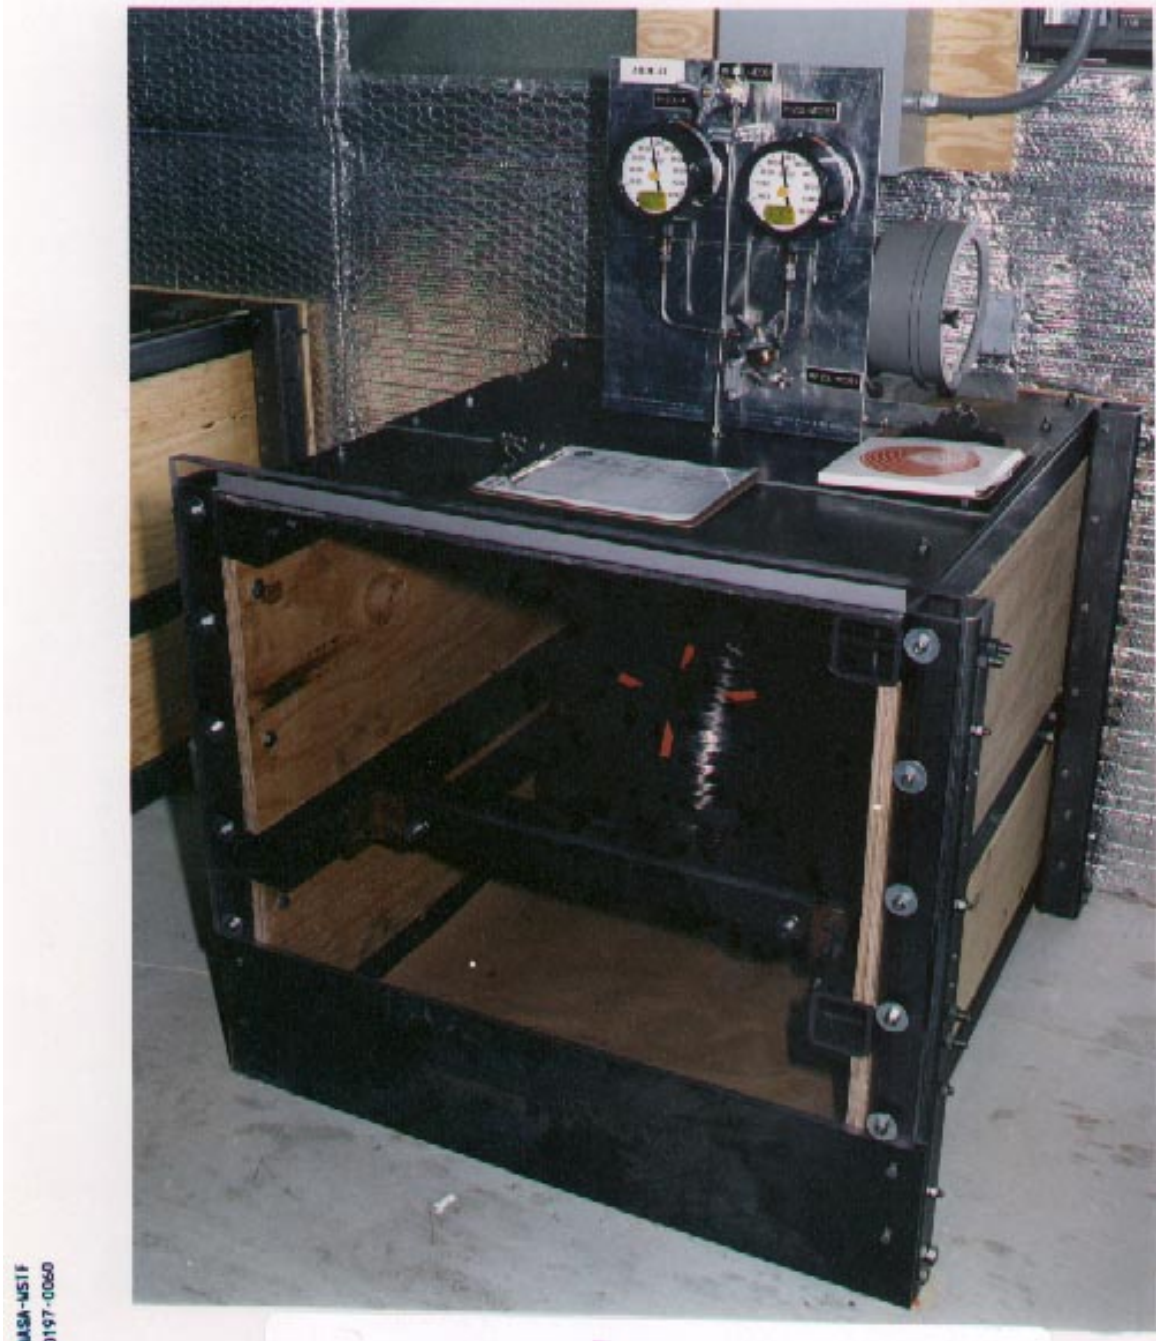
Figure 6-2. Typical blast enclosure for Subtask 3.4 testing with 19-in. spherical COPV installed.

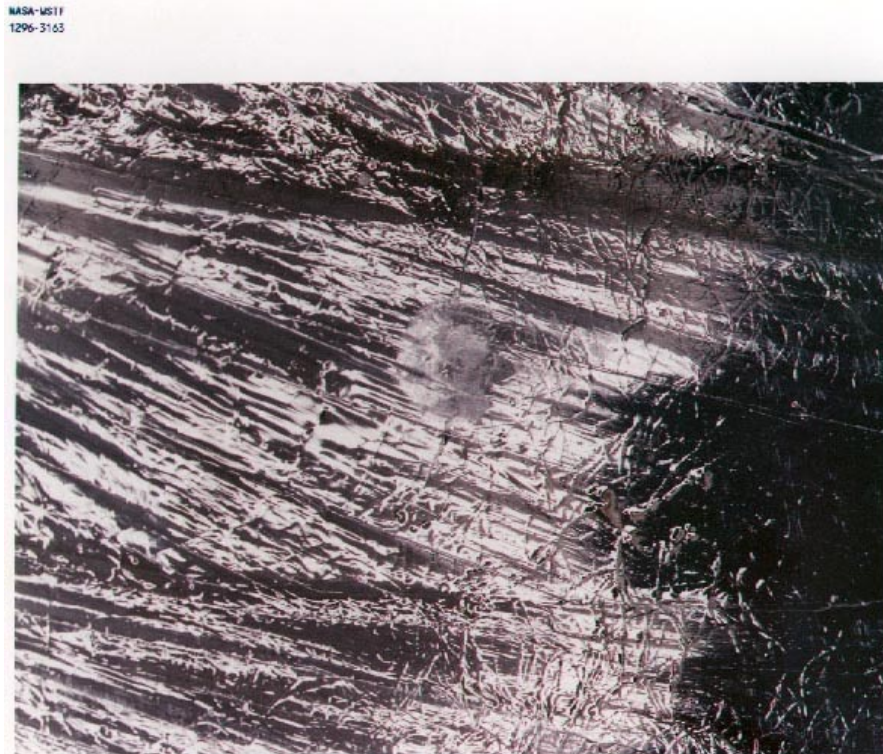
Figure 6-5. Impacted region of 19-in. spherical COPV (S/N 015), before sustained loading (approximately 3X magnification).

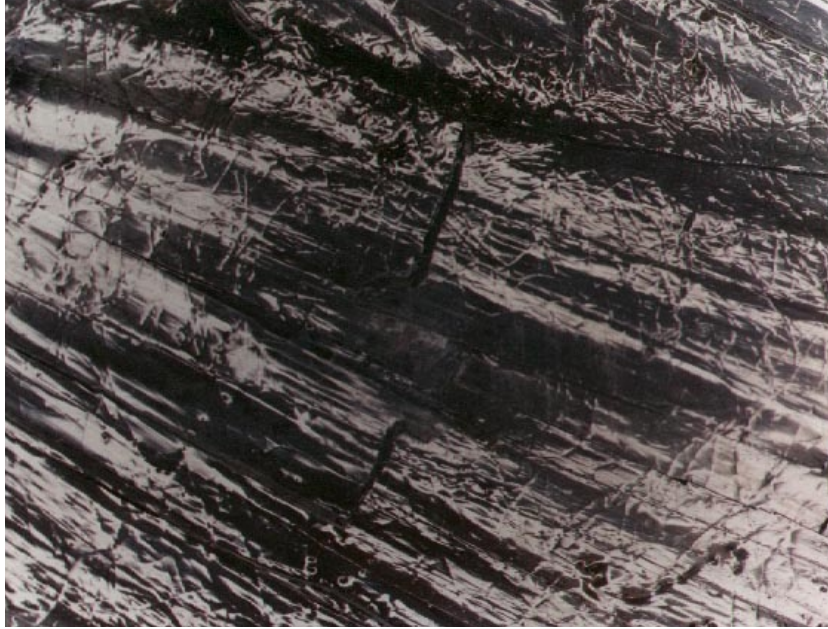
Figure 6-6. Impacted region of 19-in. spherical COPV (S/N 015), after sustained loading, showing crack growth (approximately 3X magnification).

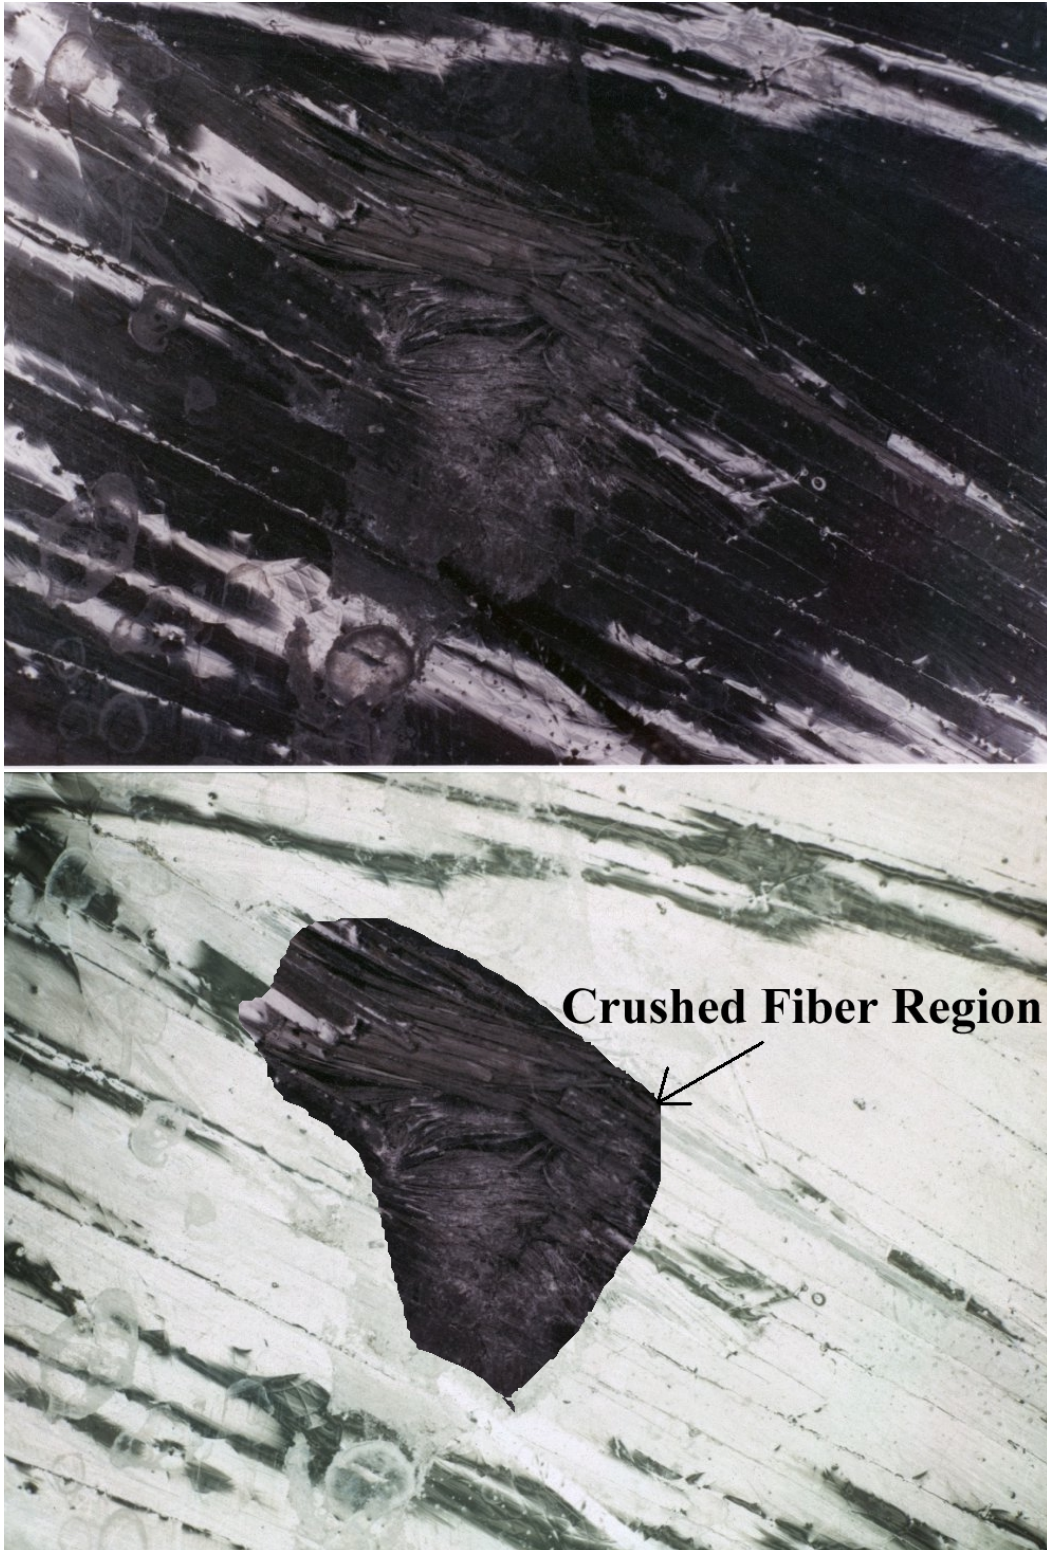
Figure 7-22. Typical crushed fibers.
